Re: Sacramento and San Joaquin Total Maximum Daily Load, TMDL, Triennial Report Comments Clear Lake, Lake County California, Nutrient and Mercury TMDL & Central Valley Regional Water Quality Control Board Public Hearing to be held on this matter October 12/13/14, 2011 11020 Sun Center Dr., Rancho Cordova, Ca. 95670-6114

CLEAR LAKE WATERSHED

Algal toxins bioassessment – Clear Lake, July/August 2010

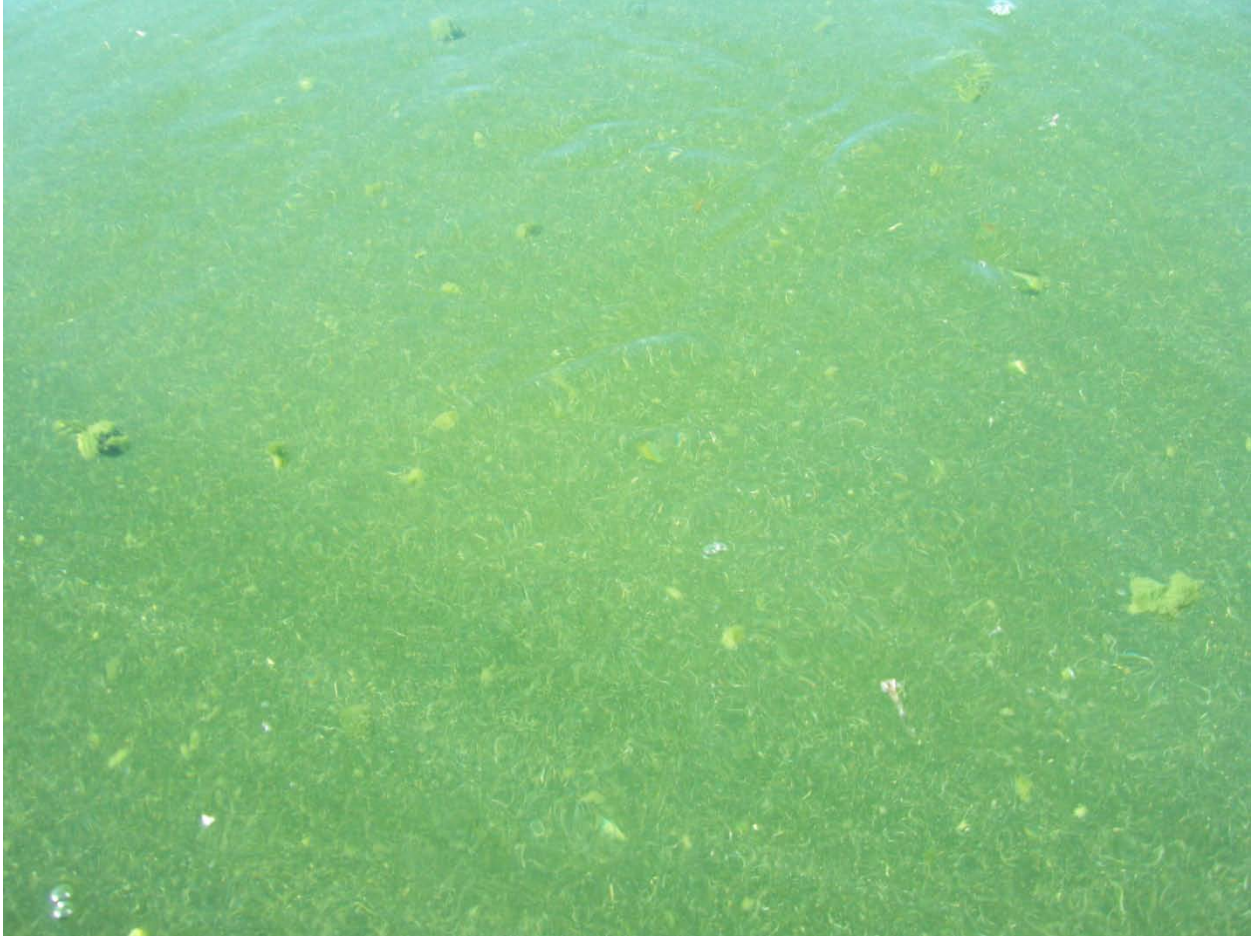
Clear Lake - June 2010

Picture of cyanobacteria growth observed in the surface water of the Lower Arm of Clear Lake (June 2010). The filamentous cyanobacteria were *Anabaena sp.*, *Aphanizomenon sp.* and *Lyngbya Cincinnati* (*Phormidium cincinnatum*). Some macrocolonies can be seen floating in surface. Other potentially harmful cyanobacteria such as *Microcystis spp.* were also present but not as these filamentous cyanobacteria.
Picture: Cécile Mioni

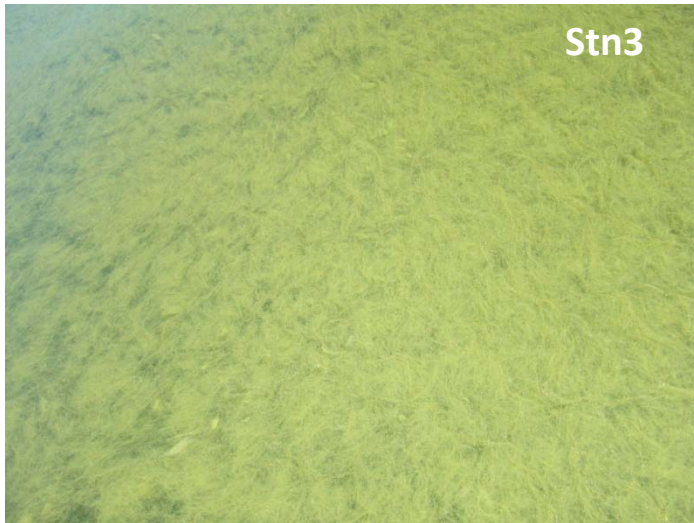
Clear Lake – July 2010

Lyngbya circinnati was the dominating cyanobacteria present in the mat in the Lower Arm.

Some clumps were rotting in the surface of the lake, releasing some fool odor.

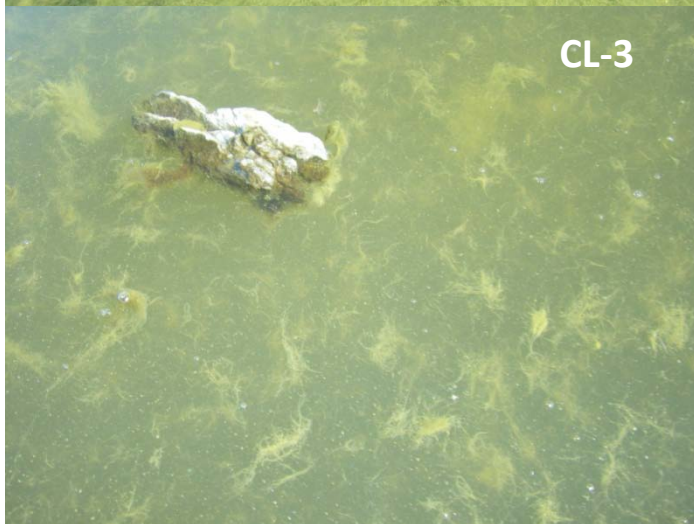
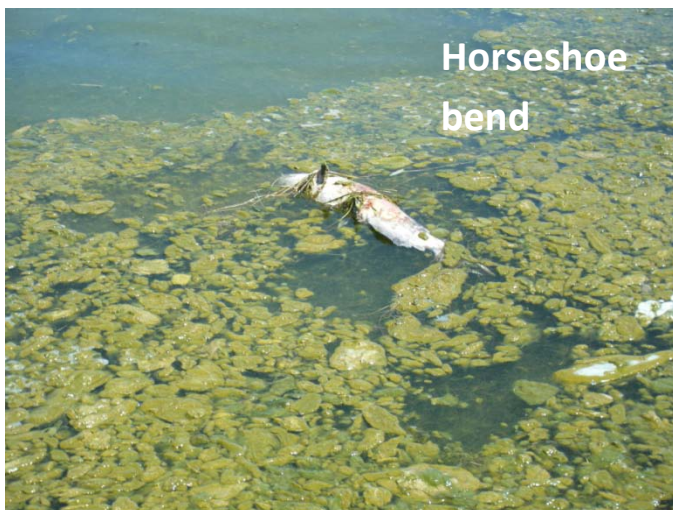
Horseshoe bend cyanobacterial scum/mat was dominated by *Anabaena* and *Lyngbya*.

We saw a couple of dead fish but we did not investigate the cause of death.

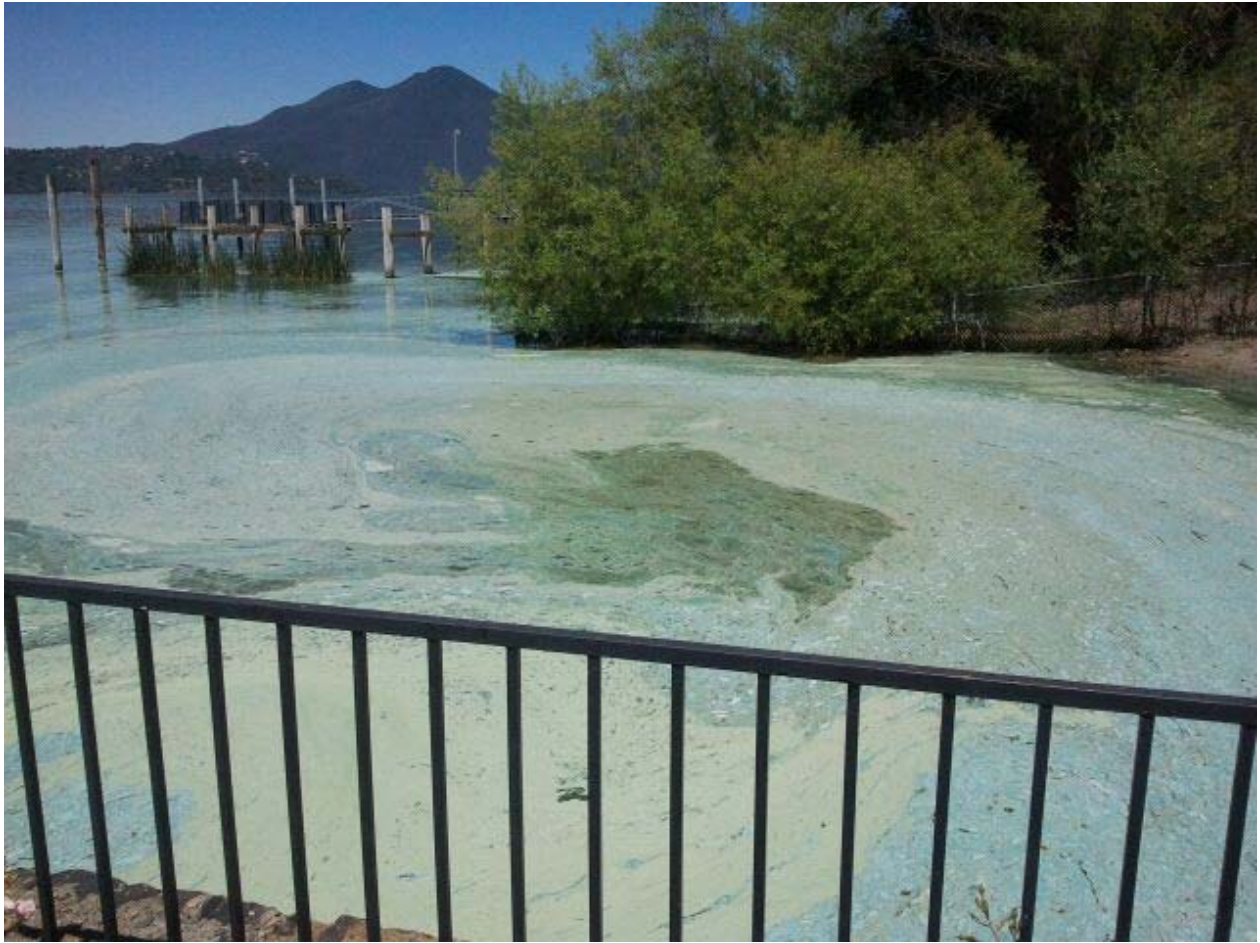
Figure 4. Picture of the cyanobacteria bloom located northwest of station 513LAK004 (lower arm, Manatee cove, near Clearlake) as observed on June 20, 2011 (credit: Samir Tuma, Kila properties). Cyanobacteria mats can be observed in surface.

A massive mat-forming bloom event occurred in the Lower Arm 4 days after our sampling event (June 20, 2011) just northwest of station 513LAK004 (figure 4). In order to investigate this cyanobacterial bloom, extra surface water samples for taxonomy/enumeration and toxicology assessment were collected by Lake County at station 513LAK004 on June 23, 2011. However, this extra sampling event took place under strong winds conditions and no mats were evident at the time of sampling (figure 5). These strong winds might have dispersed the mats. Field observations suggest that the cyanobacteria assemblage was dominated by filamentous cyanobacteria. Microscopic taxonomy/enumeration as well as toxicology analysis of these extra samples are in progress.

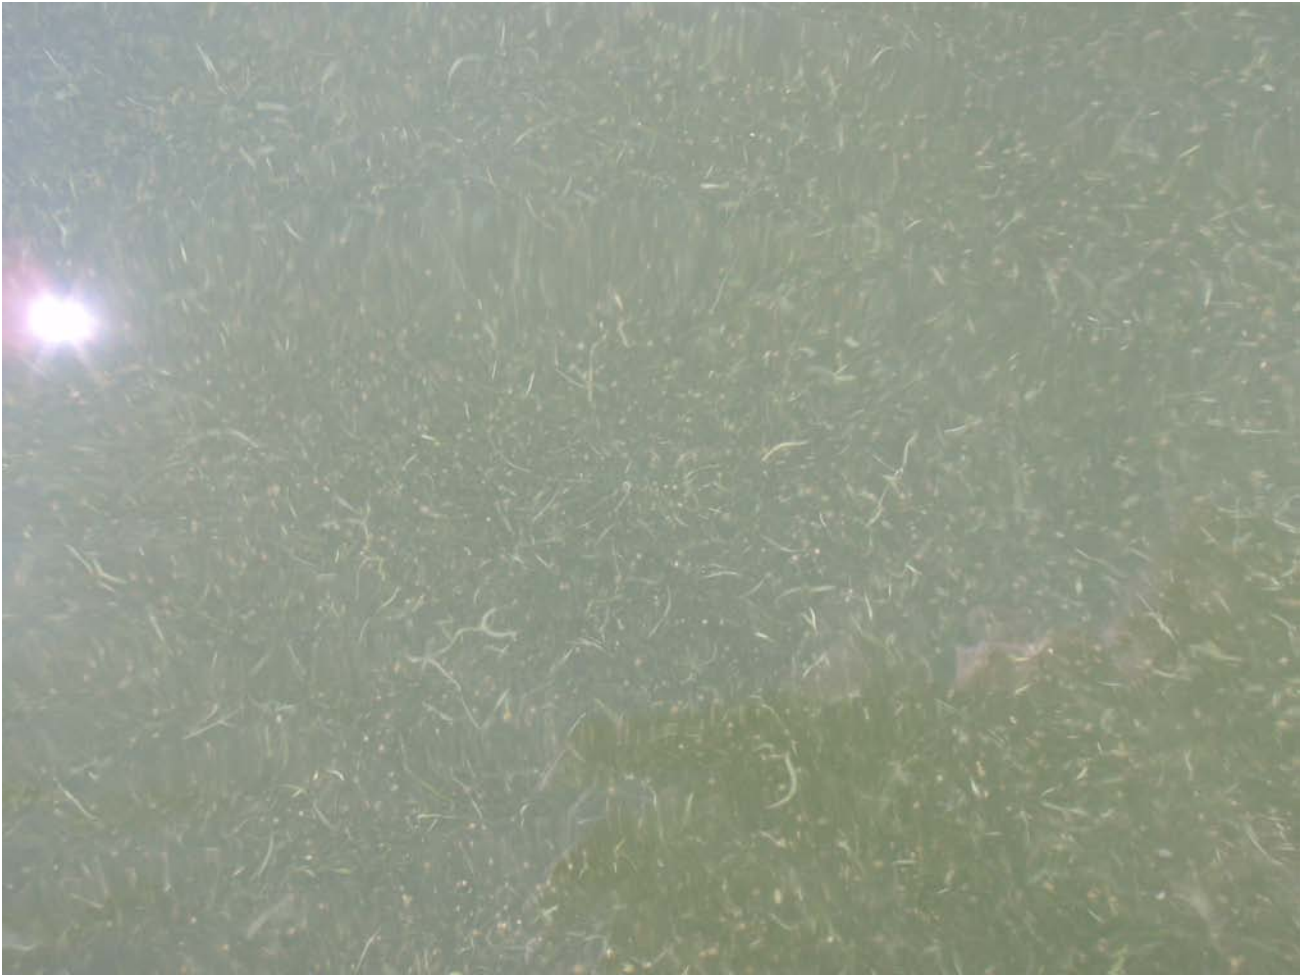
Figure 5. Picture of the cyanobacteria bloom located at Redbud park, south of station 513LAK004 (Manatee cove, lower arm, near Clearlake) as observed during the sample collection on June 23, 2011. Strong winds dispersed the newly formed mats before the sampling event took place (credit: Tom Smythe).
